WIRE MESH REINFORCEMENT
IN BITUMINOUS RESURFACING

Ernest Zube

Presented at the 35th Annual Meeting
of the Highway Research Board
Washington D.C., January 16-20, 1956

Road X-Sol-7-G

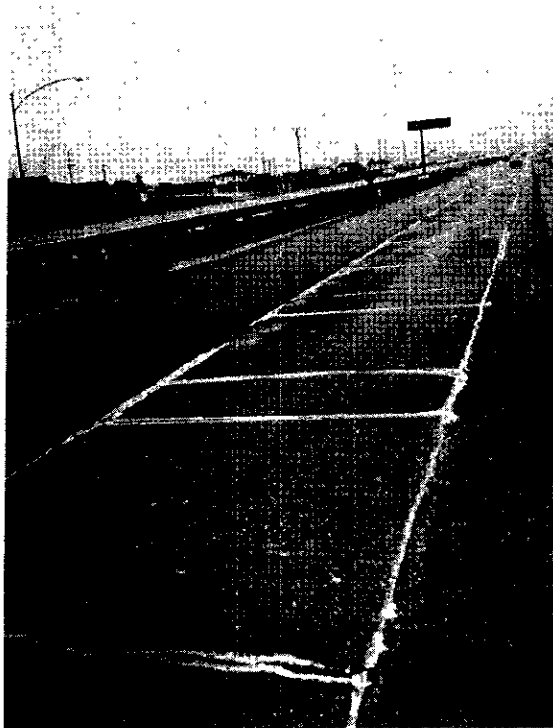
FIG. 1

Typical Reflection Cracking.

Note absence of cracks in passing lane at left.

Cracks began to appear after 1 month.

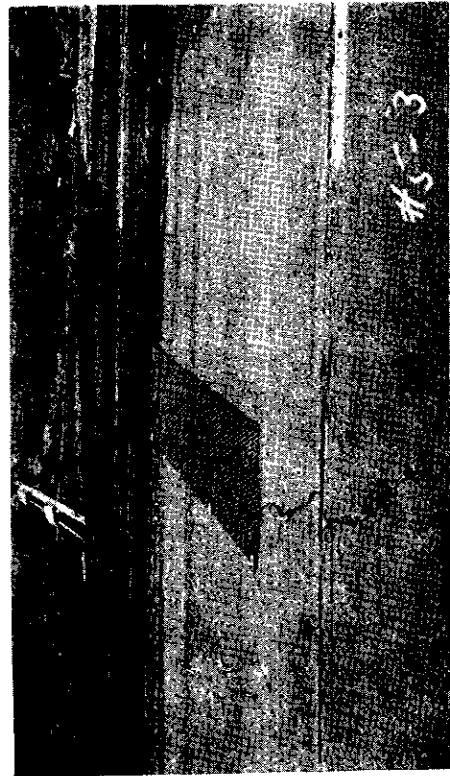
FIG. 9
2 ft. wide sheet placed over random crack.

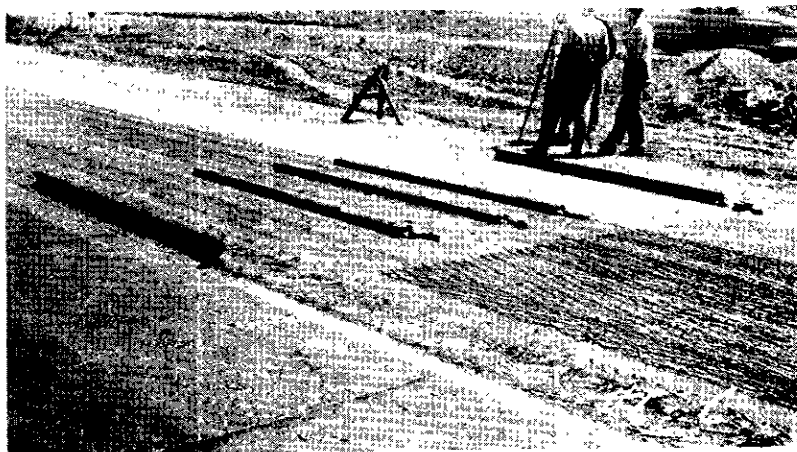
FIG. 13
Sleds used to hold down
road mesh and welded wire fabric.

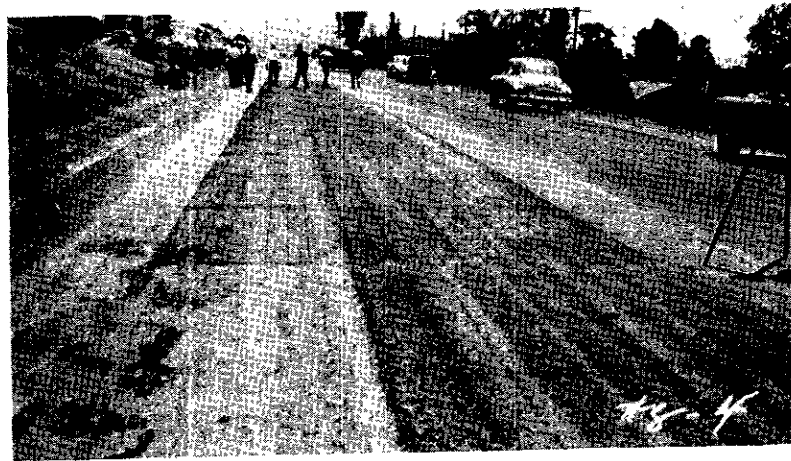
FIG. 19
Laying 3-by 6-in. wire fabric.
Left edge covers 4 ft. of cement treated base.
